FACILITY STATUS CHANGE FORM

Date Submitted: July 8, 2013	Area: 300 Area	Control #: D4-300-086
Originator: Chris Strand	Facility ID: 331C	
Phone: 554-2720	Action Memorandum: DOE/RL-2010-22, Rev 0.

Attachment 1: Facility Information

Attachment 2: Project Photographs

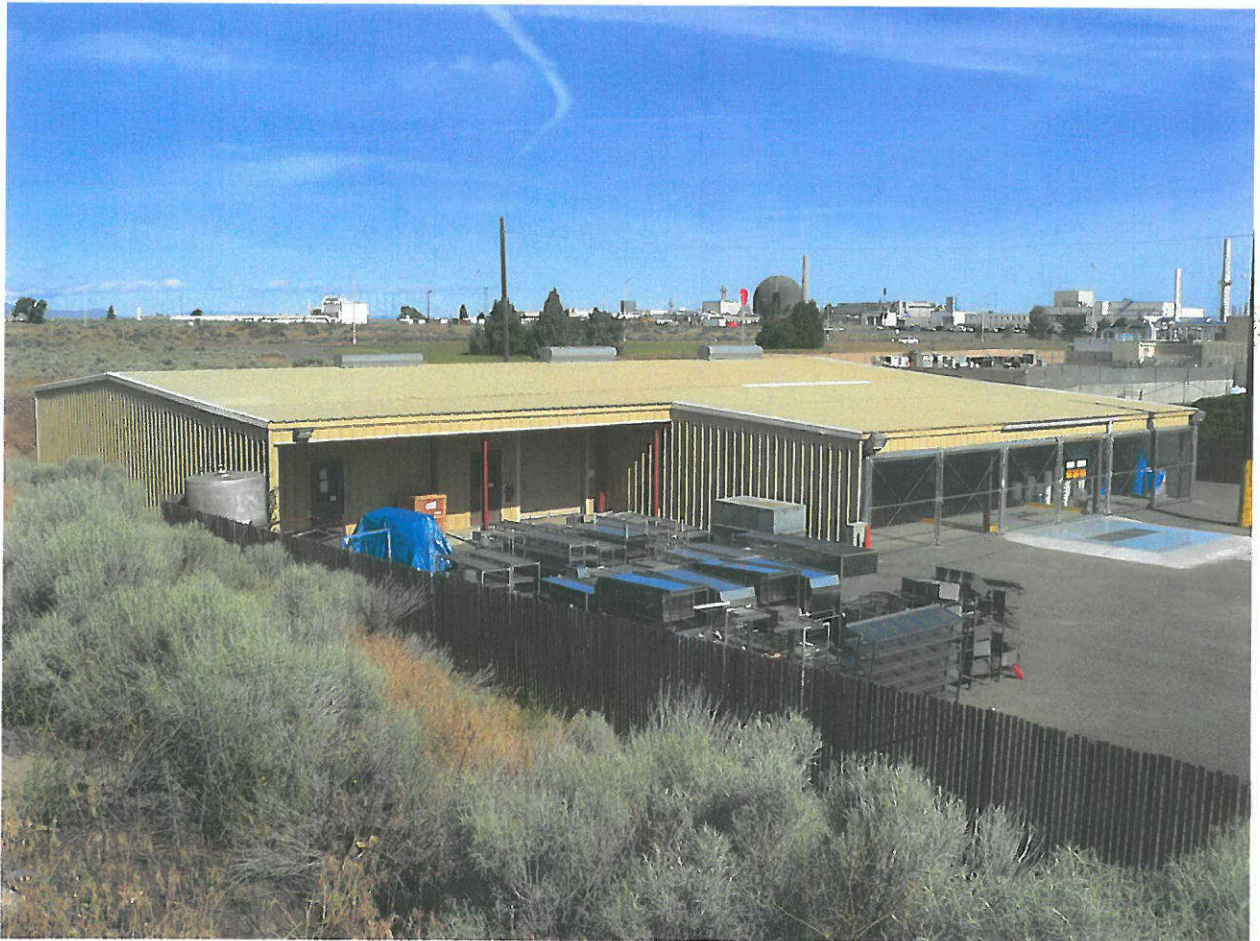
Photograph 1: 331C, looking northwest on June 5, 2006.

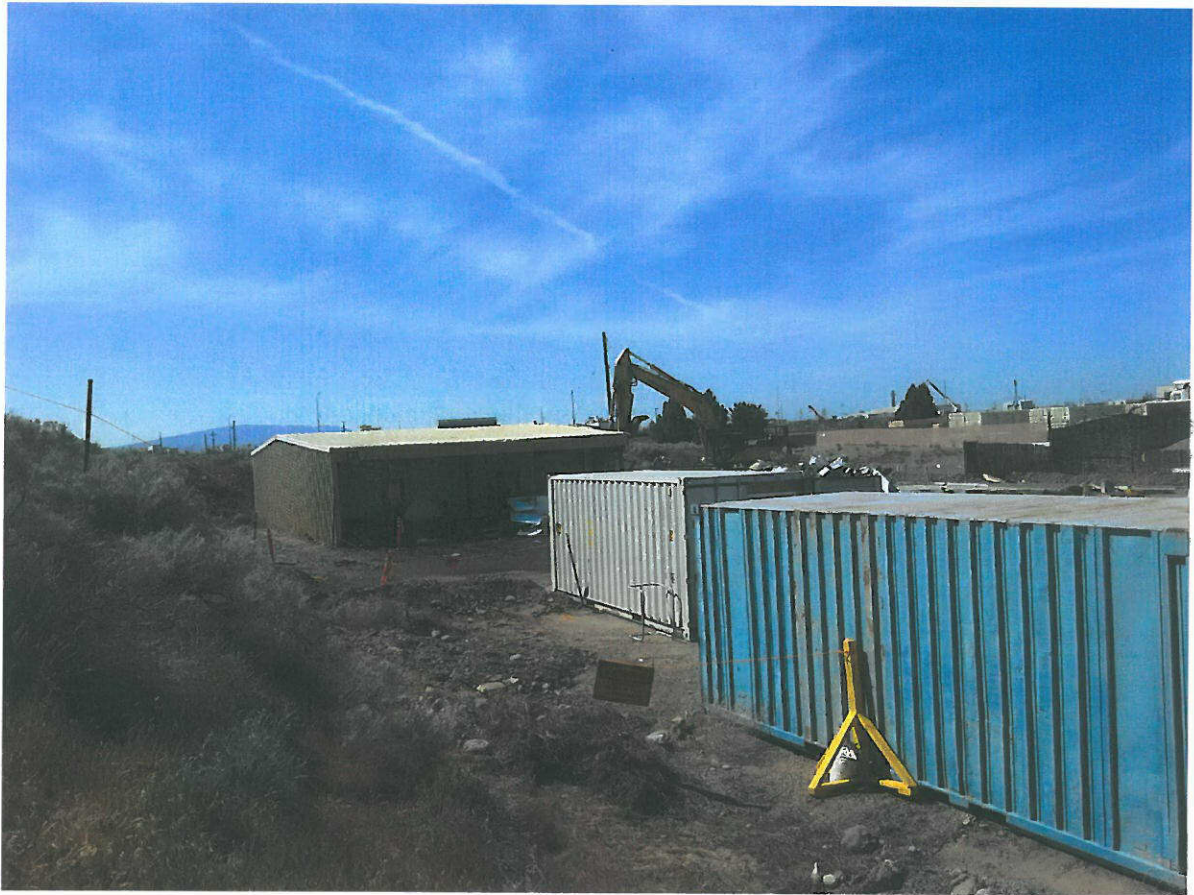
Photograph 2: 331 during demolition looking west on May 1, 2013.

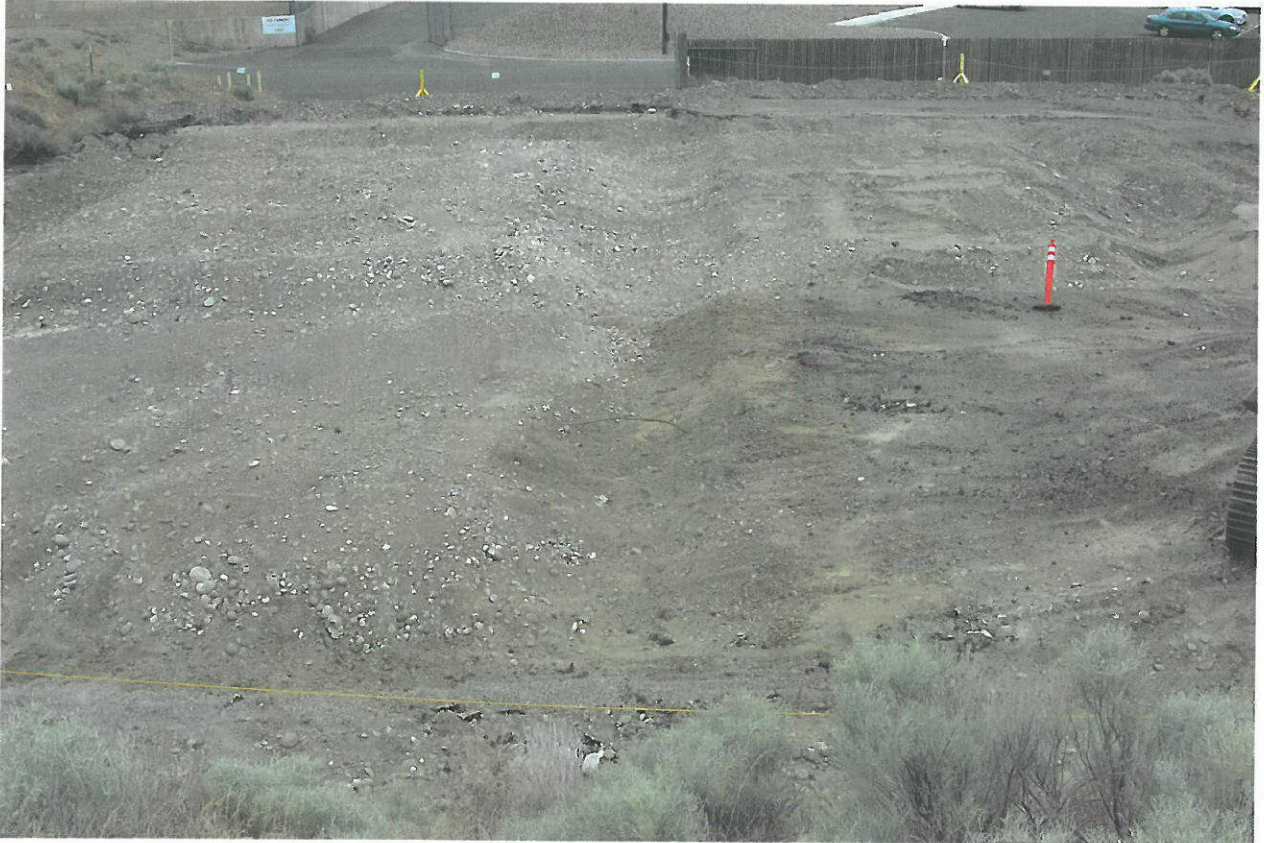
No anomalies were discovered during the below-grade removal of 331C. No soil staining within the excavation was observed and GPERS surveys identified no radiological contamination. The excavation was backfilled with clean fill material.

**Photograph 3: 331C Excavation following slab demolition,
looking north on May 21, 2013.**

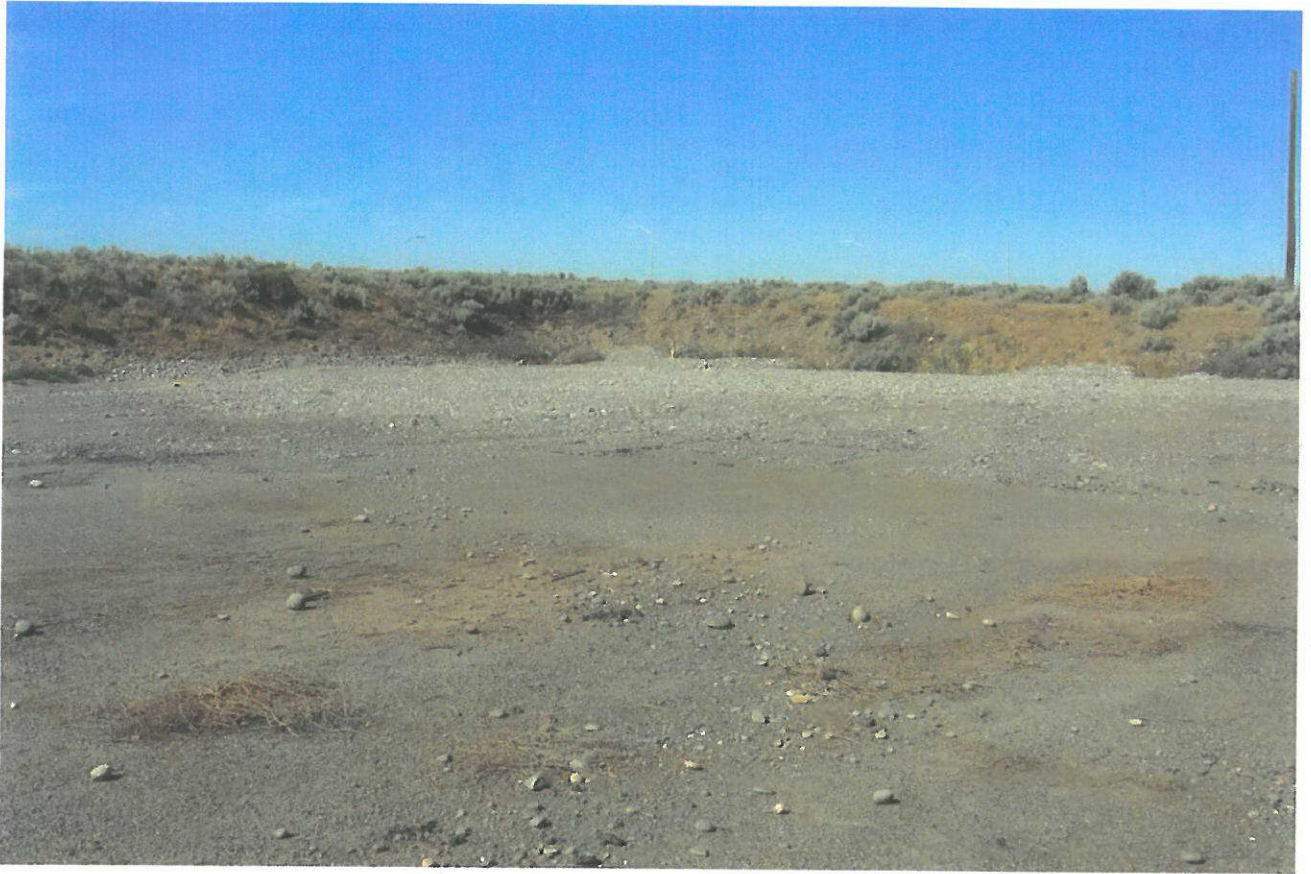
The excavation was backfilled with clean material following GPERS Surveys. No radiological or IH postings remain.

Photograph 4: 331C following backfill looking southwest on July 3, 2013.

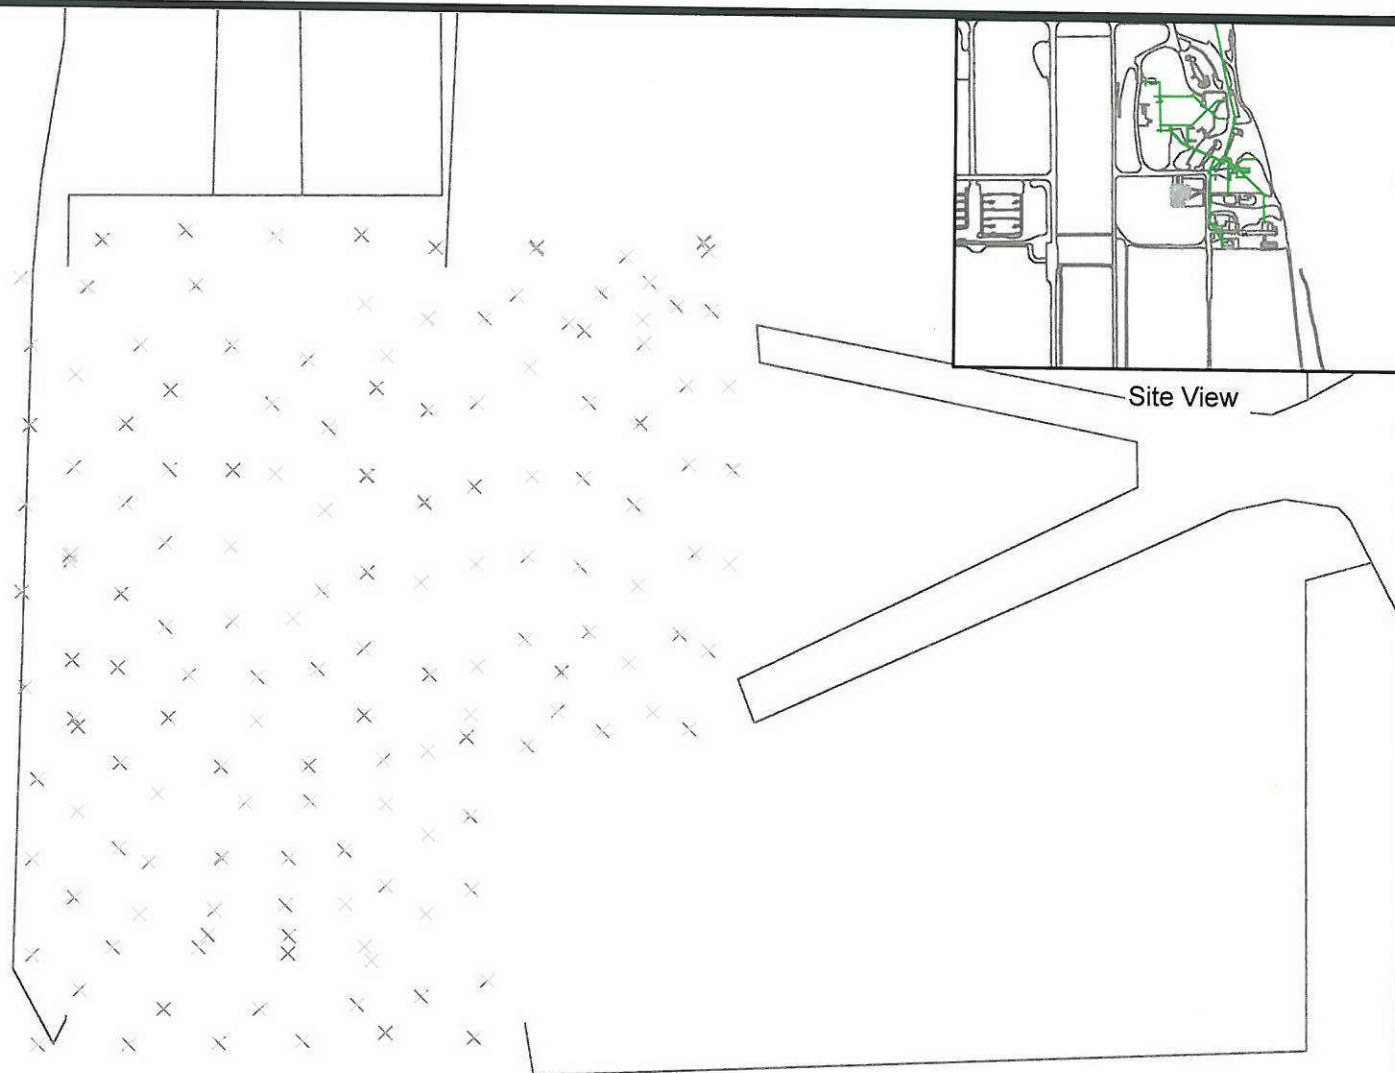
300 D4 331C GPERS Radiological Survey Beta Track Map

Bkg Location
1,185m NW
295 cpm

Coverage File: D4_0150
Number of Data Pnts: 160
Type of Survey: beta
Max GCPM: 508
Avg Bkg CPM: 295
Survey Date: 5/30/2013
Area Surveyed: 865 m²
Project File: ESRFRM130043B
Pdf File: ESRFRM130043BC
